# AquaBlok® Installation Profiles

**Site Location:** *US EPA Region 5*  
I-475 Jeep Pkwy. Interchange, Toledo, Ohio

**Project Status:** Completed September 2012

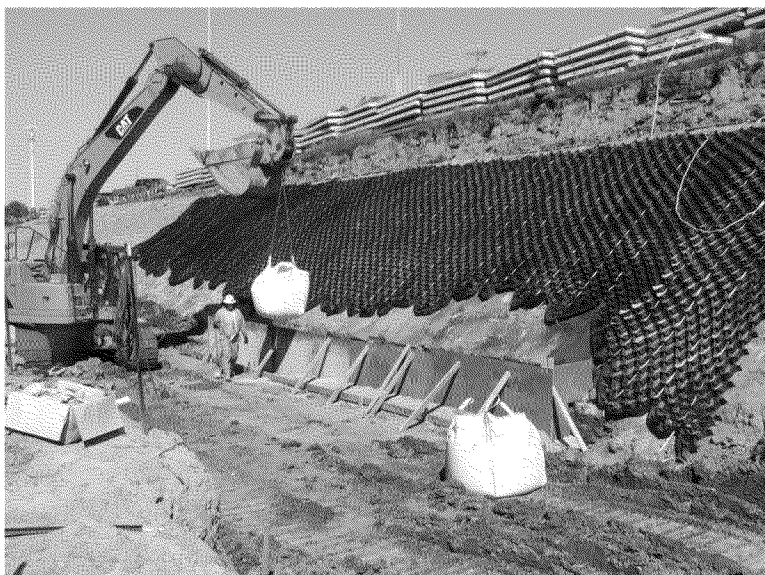
Above: AquaGate Placement into Form at Base of Slope

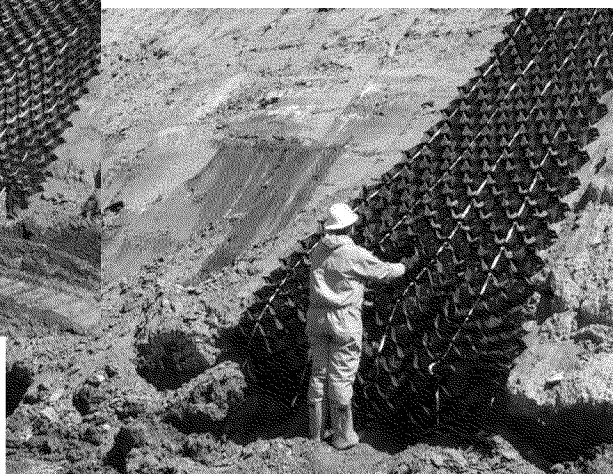
Below: Installation of Cellular Slope Stability Material (Geocell)

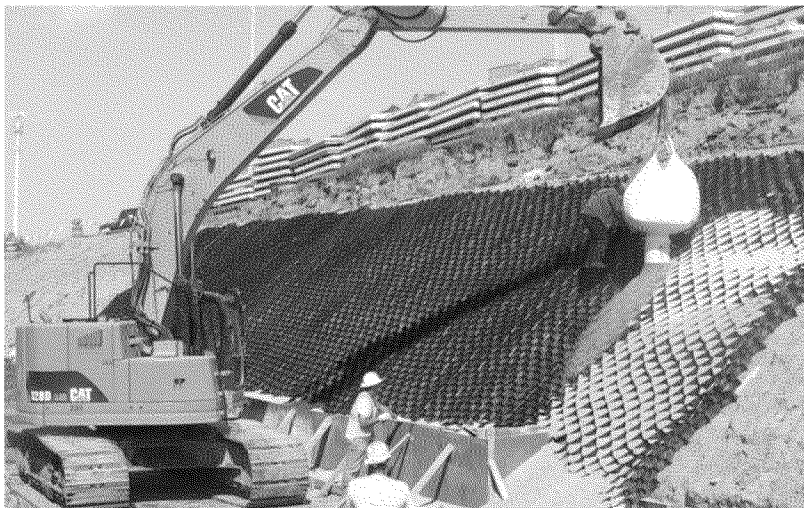
Above: AquaBlok Placement into  
Cellular Slope Stability Material

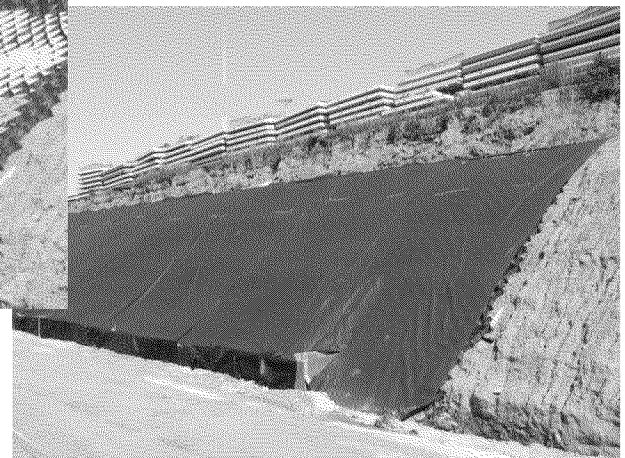
Below: Completed Installation with  
Geotextile Cover – For Protection  
Prior to Backfill of Slope
